**CRITICAL AREAS REPORT AND  
CONCEPTUAL MITIGATION PLAN**

**MALLARD BAY  
ISSAQUAH, WASHINGTON**

*Prepared For:*  
THE BURNSTEADS

*Prepared By:*  
TALASAEA CONSULTANTS, INC.

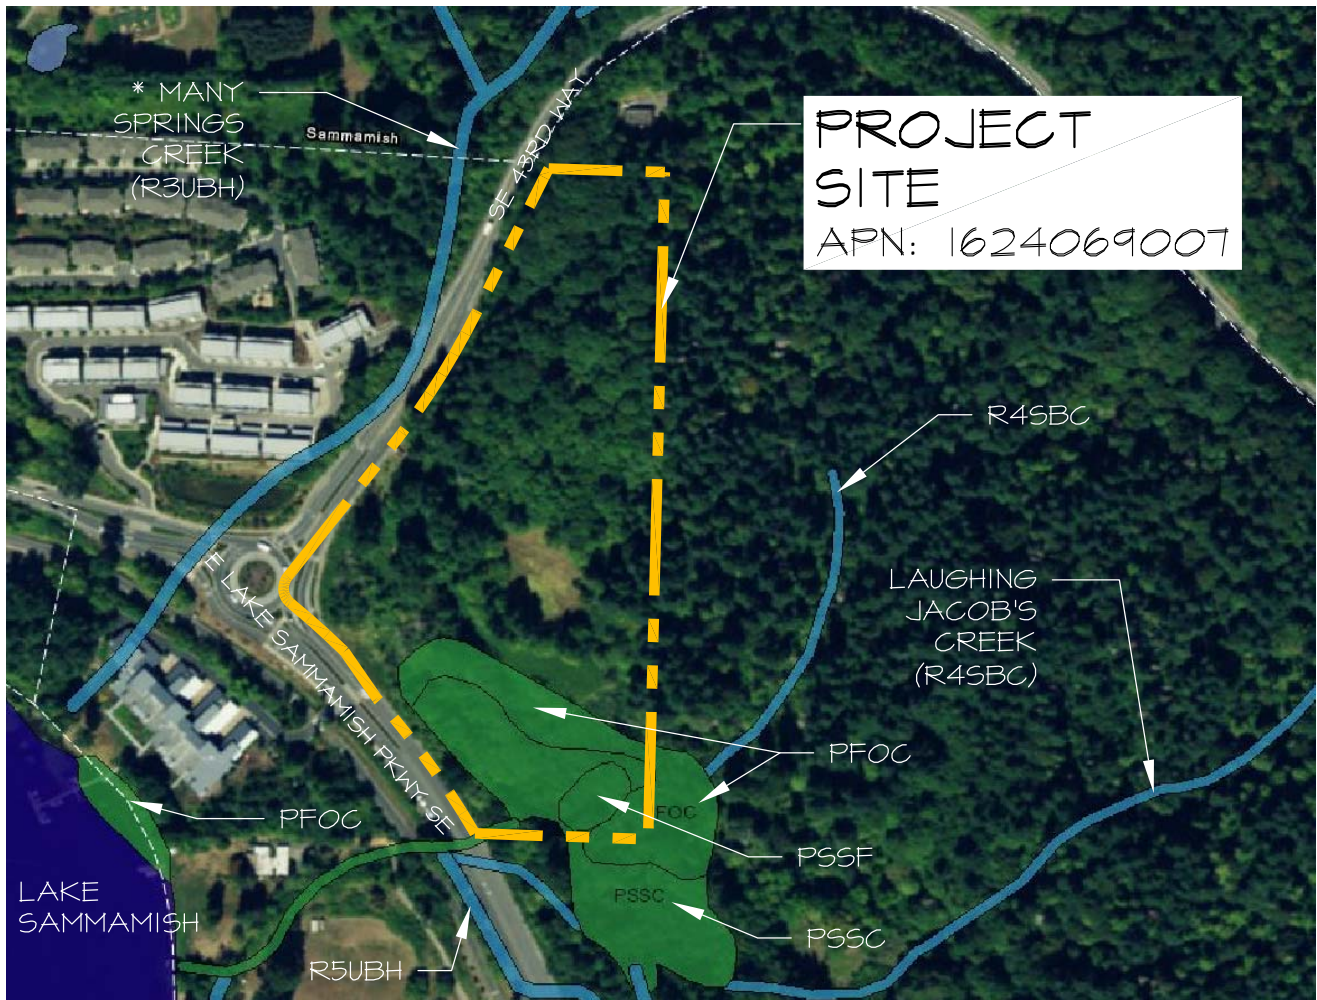
NATIONAL WETLAND INVENTORY MAP  
MALLARD BAY - LOT 7  
ISSAQUAH, WASHINGTON

TYPE	DESCRIPTION
PFOC	PALUSTRINE FORESTED, SEASONALLY FLOODED
PSSF	PALUSTRINE SCRUB-SHRUB, SEMIPERMANENTLY FLOODED
PSSC	PALUSTRINE SCRUB-SHRUB, SEASONALLY FLOODED
R3UBH	RIVERINE UPPER PERENNIAL UNCONSOLIDATED BOTTOM, PERMANENTLY FLOODED
R4SBC	RIVERINE INTERMITTENT STREAMBED, SEASONALLY FLOODED
R5UBH	RIVERINE UNKNOWN PERENNIAL UNCONSOLIDATED BOTTOM, PERMANENTLY FLOODED
